MX40 Pro LED Display Controller

V1.4.0

Release Notes

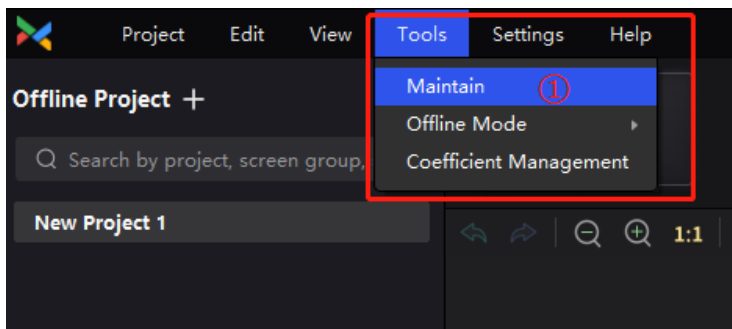
Step 1 From the menu bar, choose **Tools > Maintain**.
